# Noosa Main Beach Algae Mitigation Trial

Bobbie B. Corbett<sup>1</sup>, L. Angus Jackson<sup>1</sup>, Rodger Tomlinson<sup>2</sup>, Michael Hagan<sup>4</sup>,  
Thomas Schalcher<sup>3</sup>, Stewart Lloyd<sup>3</sup> and Lawrence Hughes<sup>2</sup>

<sup>1</sup>International Coastal Management, Gold Coast, Australia  
<sup>2</sup>Griffith Centre for Coastal Management, Gold Coast, Australia  
<sup>3</sup>University of the Sunshine Coast, Maroochydore, Australia  
<sup>4</sup>Sunshine Coast Regional Council, Noosa, Australia

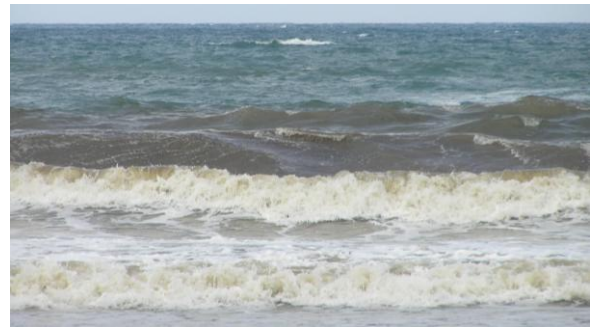
Figure 5: Algae present over the width of the surf zone

Preliminary observations indicated that pockets of algae were distinct, restricted to the width of the surf zone (Figure 5) and to defined areas alongshore which appeared to correlate with rip cells. Within this region, the algae was well distributed through the water column by turbulence generated by wave action.

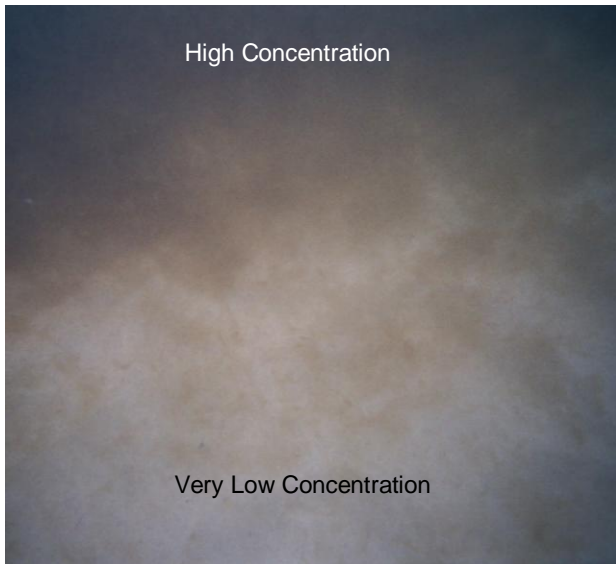
Figure 7: Patches of higher and lower concentration of algae slightly further seaward

Directly seaward of the surf zone, while the water appeared clear, further inspection revealed that algae was evident in very low concentrations throughout the water column, with very high concentrations within  $\sim 10-20cm$  of the seabed (Figure 6). Further seaward, the layer close to the seabed remained evident, with variations in concentration becoming more distinct so that 'patches' of algae became more defined (Figure 7).

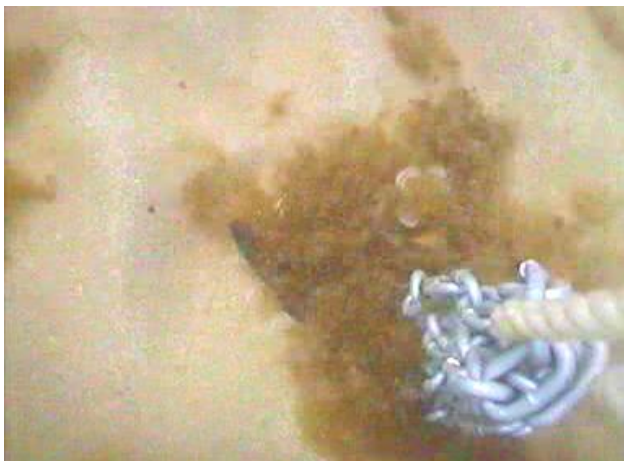
Figure 8: Sparse algae

Spot observations were undertaken using an underwater camera in locations up to 1km offshore in water up to 10m deep. Patches of algae became smaller, thinner and better defined further seaward and the algae was quite sparse in locations further offshore (Figure 8). During the inspection, no large areas were observed that were completely clear of algae, however the areas of higher concentration were patchy. As a result, it is clear that in seasons when the algae is present within Laguna Bay, there can be a significant volume of algae in the nearshore zone which can be drawn into the surf zone and onto the beach during certain conditions.

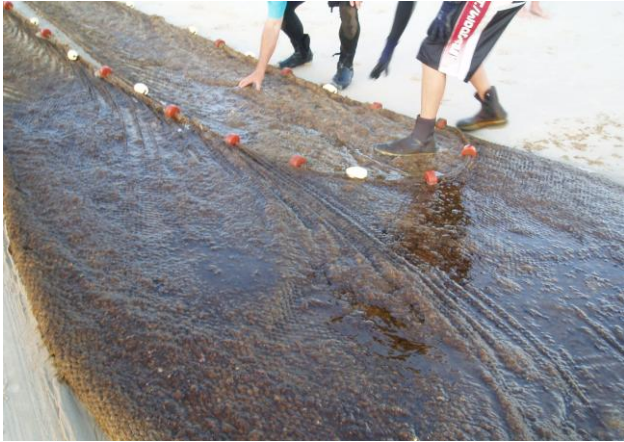
Figure 11: Algae removed from water using 20mm mesh fishing net.

A 40m long x 1m wide seine net with 20mm mesh size was handled by two people in the surf zone and removed from the water using a 4WD (Figure 11). The 20m length appeared noticeably clearer, but the volume of algae removed and successfully cleaned from the net was only

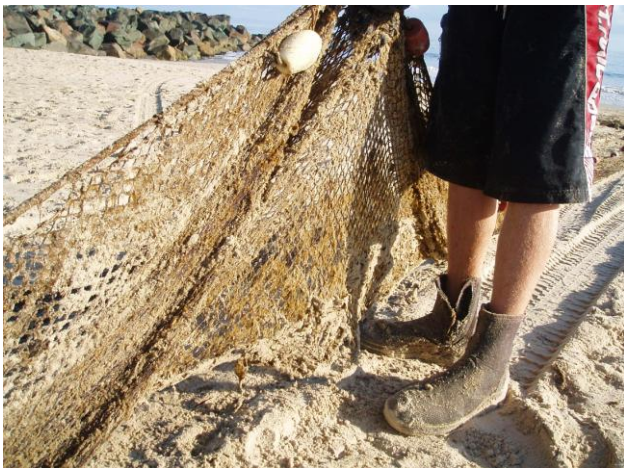
Figure 12: Mesh was clogged with algae and could not be easily cleaned.

~0.25m<sup>3</sup>. Standard procedures for net cleaning proved ineffective and a significant amount of algae was unable to be removed effectively from the net (Figure 12). Subsequent attempts were less effective as the net was already clogged with algae.

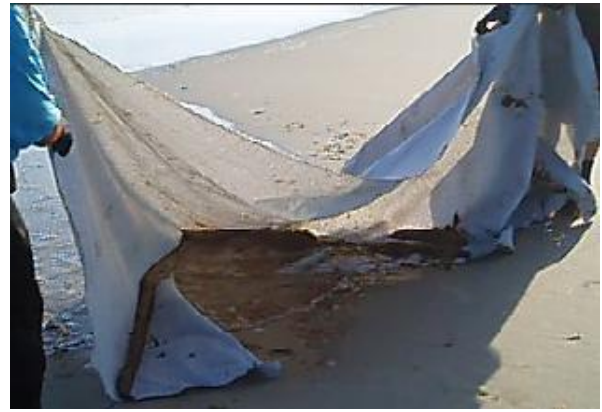
Figure 13: Algae rolling off the shade cloth

A 3m length of shade cloth was also trialled. A similar volume was removed (per metre of net), but unlike the mesh, the cloth was easily cleaned as the algae rolled off the fabric (Figure 13).

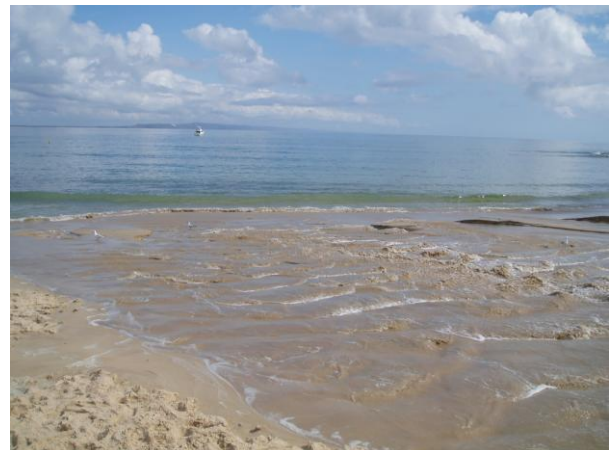
Figure 14: Algae-free water directly seaward of the Sand Shifter discharge point

The operation of the local sand backpassing operation (Sand Shifter) provided the only real low-impact mechanism for influencing current patterns that may disperse the algae. While there was a patch of clear water directly seaward of the Sand Shifter (Figure 14), a dense patch of algae was evident within 30m of the discharge point. As such, it was concluded that the effect was relatively localised and the lack of people utilising this section of beach made it clear that the discharge was not successfully creating a desirable swimming location.

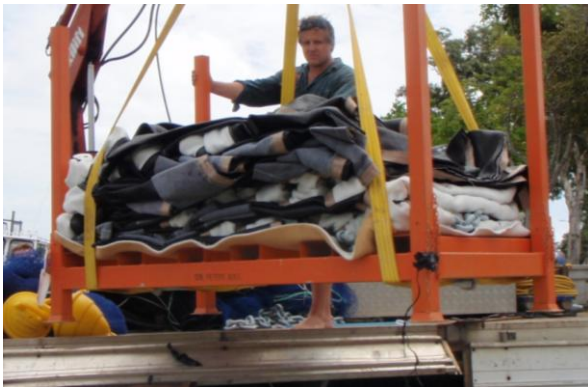
Figure 15: Seabed-based algae curtain prior to installation

The seabed based curtain was fabricated by ELCO Solutions in 2005 (Figure 15), however the algae season finished early and did not appear in subsequent seasons, so the installation of the curtain was delayed. In 2009, the newly formed Sunshine Coast Regional Council decided to deploy the curtain as a proactive measure to ensure that installation could be undertaken smoothly when required. The curtain was successfully deployed by Marine Civil Contractors in March 2009 (Figure 16).

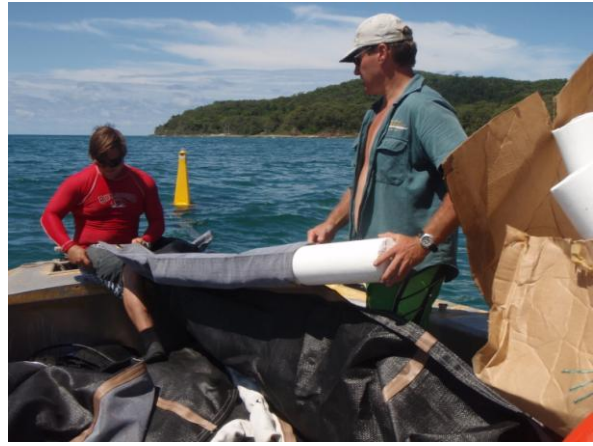
Figure 16: Final assembly and deployment of algae curtain

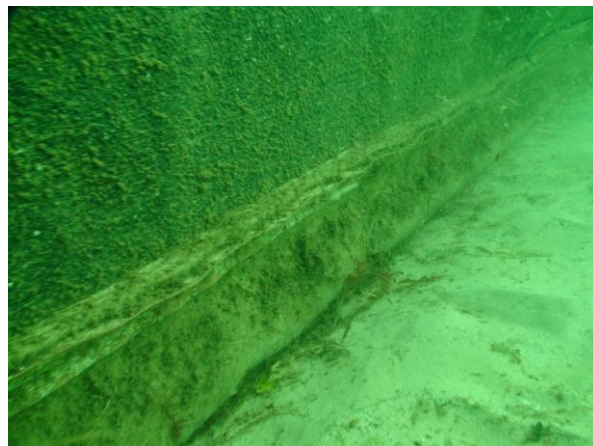
Figure 17: Seabed based algae curtain resting on seafloor

The curtain was deployed in water depths between 3.8 – 4.5m LAT, giving ~3m clearance above the curtain at all times. Once deployed and pulled into position, the curtain sat vertically in the water column with the centre of the chain at the seabed level (Figure 17) and the top of the curtain moving horizontally by up to ~0.5m during the sets ( $H_{max} = 1.3m$ ). These observations suggested that preliminary design was suitable.
